Erosion and Foreign Object Damage of Thermal Barrier Coatings

J. R. Nicholls and R. G Wellman

Cranfield University
Cranfield, Bedford
UK

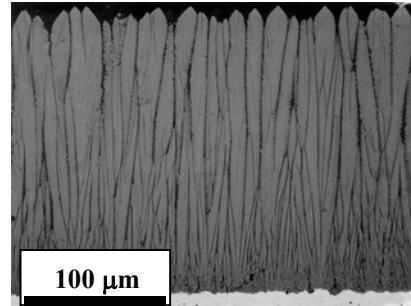
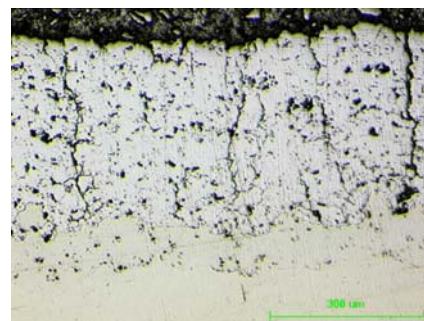
a) Micrograph of a Plasma sprayed TBC

b) Micrograph of an EB-PVD TBC

Figure 1 Typical ZrO₂-(7-8)wt%Y₂O₃ thermal barrier coating microstructures

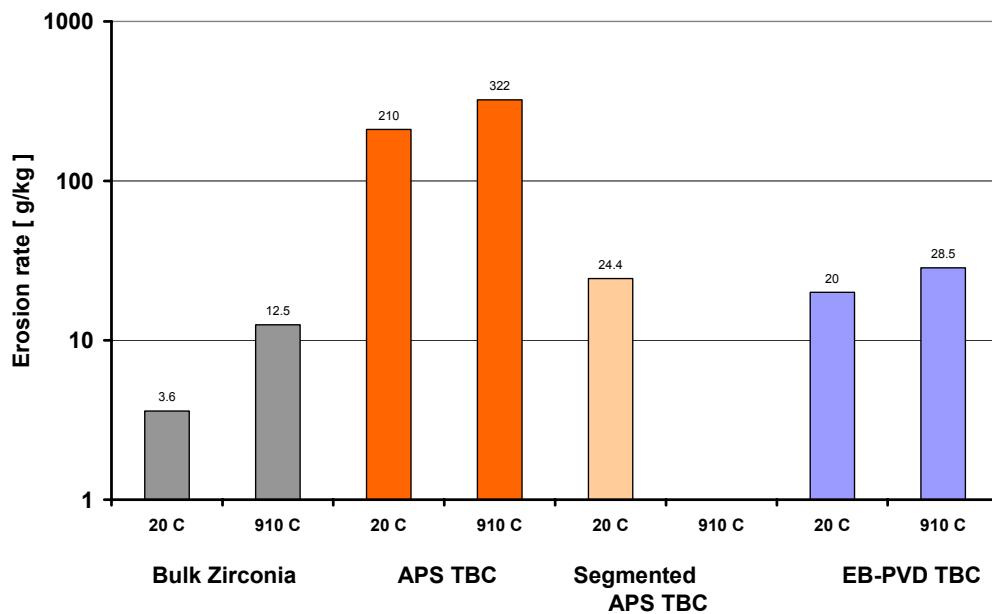
It can be seen from Figure 2 that at room temperature (20°C) and 910°C, the columnar EB-PVD microstructure is more erosion resistant than the splat-like APS microstructure by a factor of approximately x10, under normal (90°) impact conditions. Erosion rates were respectively 20 g/kg (20°C, 140m/s) and 28.5 g/kg (910°C, 230m/s) for the EB-PVD columnar microstructure compared to 210 g/kg (20°C, 140m/s) and 322 g/kg (910°C, 230m/s), for the splat-like APS microstructure. The vertically microcracked plasma sprayed TBC by comparison – although only tested at room temperature – exhibited erosion rates much closer to that expected for EB-PVD ceramic than APS ceramic, namely 24.4 g/kg (20°C, 140m/s).

Figure 2 Comparison of the erosion performance of air plasma sprayed, EB-PVD and segmented plasma sprayed coatings at RT and 910°C. Data for bulk $\text{ZrO}_2\text{-}7\text{wt\%Y}_2\text{O}_3$ ceramic is included as a reference

All coating morphologies are significantly less erosion resistant than the bulk ceramic (the EB-PVD ceramic erodes at x 2 to x 5 the rate of bulk zirconia, depending on test temperature), confirming the premise that the crack-like features inherent in the design of successful thermal barriers must compromise the erosion performance. The ability of the columnar boundaries in the EB-PVD ceramic microstructure (and the vertical microcracks in the segmented APS TBC) to limit crack propagation is thought to account for its improved erosion resistance over the conventional air plasma sprayed microstructure.

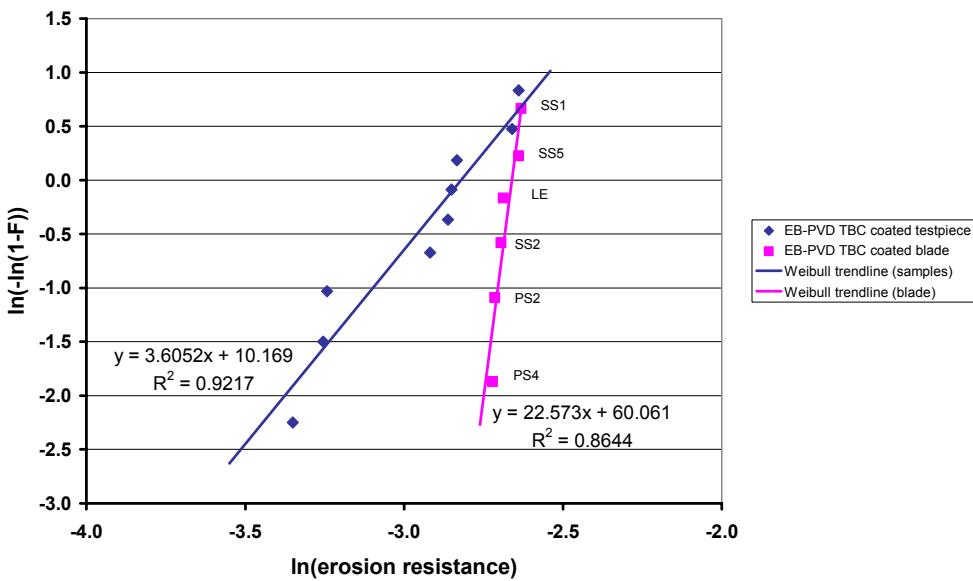
Measured erosion rates on test pieces (TBC thickness 360 μm), when tested at 90° impact and 910°C using 100 μm alumina at a velocity of 230m/s, varied between 14.0 and 28.5g/kg with a mean of 19.8g/kg. The data, see Figure 3, was found to fit a classical Weibull model, when plotted as erosion resistance (1/erosion rate) where F_w is the Weibull probability, E is the erosion rate, E_o is a minimum erosion rate under these test conditions and β , η are constants.

Where the Weibull modulus β takes a value of 3.6 for batch to batch variations in EB-PVD TBC manufacture. The characteristic erosion resistance (η) for this data set is 0.060 kg/g (corresponding to a characteristic erosion rate of 16.8 g/kg).

Figure 3 Weibull analysis of the repeatability of erosion data for EB-PVD thermal barrier coatings tested at 910°C [Included in this figure is data taken from Figure 4 on a blade sample, which represents the most likely within batch variation: Note: the R^2 values quoted on the figure are a measure of the ‘goodness of fit’; an R^2 value of 1.0 is a perfect fit to the data].

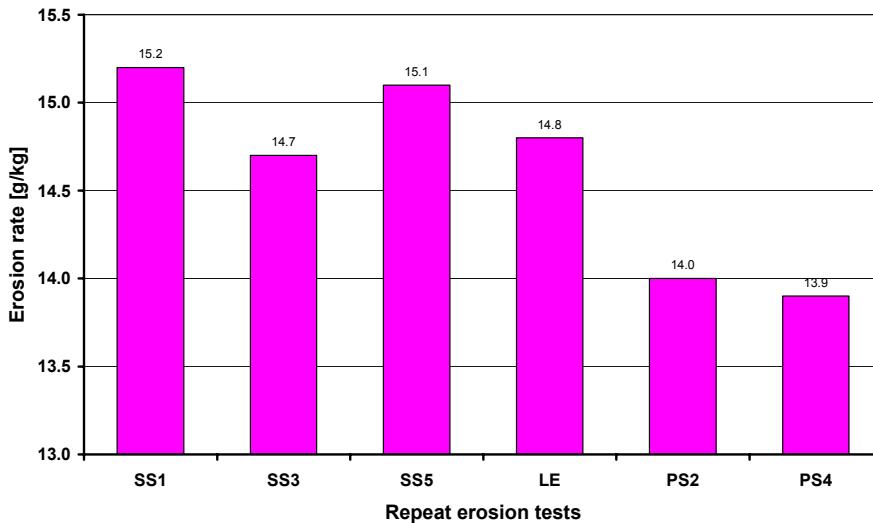
Figure 4 Variation in erosion rate of a commercial EB-PVD TBC (RT33) around a blade profile.

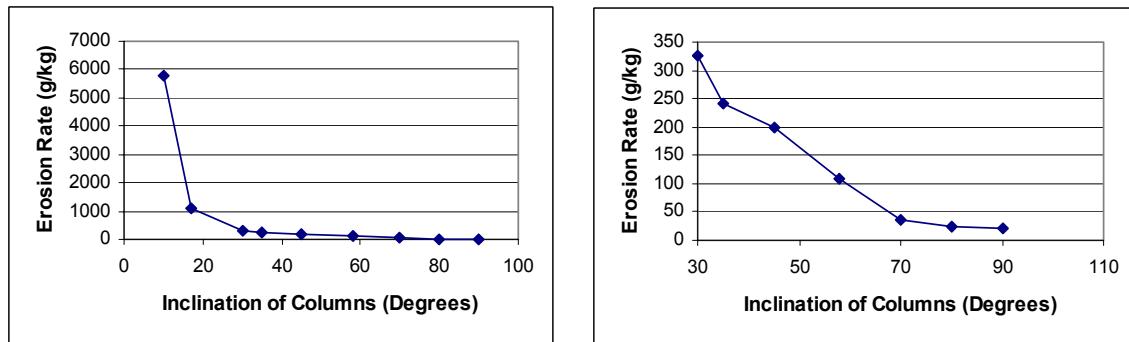
Good erosion resistance of EB-PVD thermal barrier coatings requires that the columnar microstructure is vertically aligned. Any off axis symmetry modifies the mode of column fracture and this has a significant effect on the erosion rate. Figure 5 illustrates the increase in erosion damage that can occur when the TBC growth direction is inclined. On impact, fracture may occur throughout the coating (rather than in the near surface region as discussed in the next section for a vertically aligned EB-PVD TBC microstructure) with some fracture at mid-column length and others near to the bond coat surface. This behaviour is believed to result from bending of the columns during impact, such that the largest defect in the column surface causes fracture.

Figure 5 Influence of column inclination on the erosion rate of EB-PVD TBCs

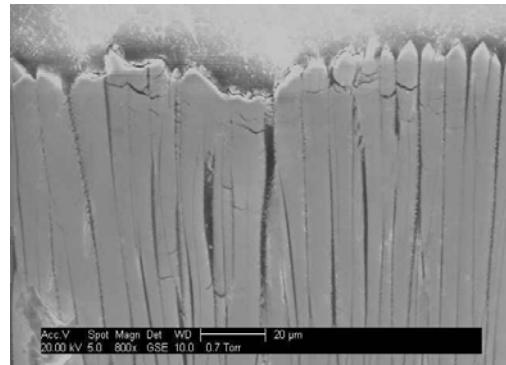
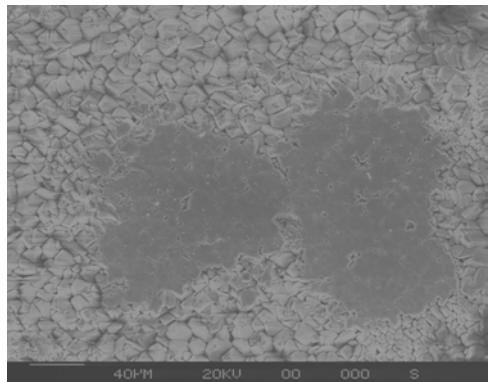
Figure 6 Cross sections of eroded samples of TBCs showing near surface cracking, a) at room temperature and b) at 800°C

Erosion is the standard term used by most authors in the literature to describe the progressive loss of material from the surface of an EB PVD TBC while still maintaining the integrity of the columnar microstructure. This occurs under small particle impact conditions where the near surface region, the top 20 μm , of the individual columns are cracked due impact. Material is lost when a number of neighbouring columns have been impacted and cracked. The cracks are observed to initiate at the elastic/plastic interface that occurs under the impacting particles [38,39], this type of damage is illustrated in Figure 6.

The relevance of room temperature erosion testing has been questioned as to whether it is representative of high temperature erosion. As far as can be seen from Figure 6a and 6b the same mechanism of near surface cracking occurs at both room and high temperatures. Although, it can be argued that the degree of plastic deformation that can be accommodated by the ceramic at elevated temperatures is greater than at room temperature. However, analysis of samples eroded at both room temperature and high temperature showed that there was no difference in the observed depth at which the near surface cracking occurred during Mode I erosion of the samples.

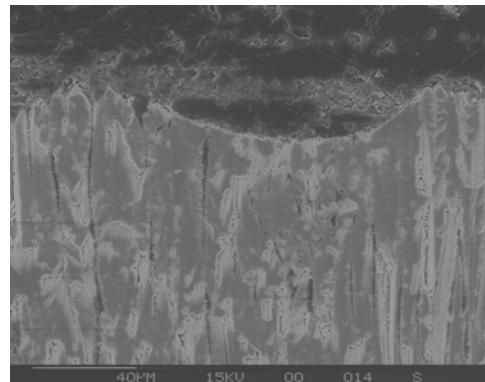
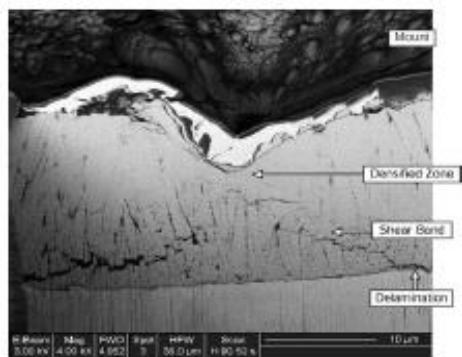
This is a relatively new observation and is essentially a transition mechanism that occurs between erosion and FOD. It involves the compaction of the columns without the cracking that occurs during erosion or the gross deformation of the columns that occurs during FOD. This type of damage has been observed under both room temperature and high temperature impact conditions, and is illustrated in Figure 7. Figure 7, a room temperature impact, illustrates the ability of EB PVD TBCs to deform plastically, even at room temperature. Note however, that this type of plastic deformation, as in Mode I erosion, is most likely in the form of the densification of the near surface individual columns. Penetration depths are expected to be greater than under Mode I erosion with the higher impact energies involved in Mode II compaction.

Figure 7 Micrographs of single impact Mode II compaction damage showing compaction of the coating, note the absence of cracking, a) top view, b) cross section. [200µm particle impact, at 170m/s at room temperature]

Thus, in this intermediate/transition damage mechanism there is compaction of the EB PVD TBC columns, but neither the near surface cracking of Mode I nor the gross plastic deformation, kinking and cracking of Mode III is observed. This compaction damage is attributed to the high porosity levels in the columns, which are never 100% dense, often containing up to 15% of nano-sized porosity together with intra-column pores. A similar type of compaction occurs during Mode I, here the damage is limited to one or two neighbouring columns, with any lateral cracks believed also to initiate from the elastic/plastic interface. However, when the impact is spread over a significant number of columns, as is Mode II compaction damage, cracks do not initiate at this interface thus the transient loads on each column must be lower, below the fracture stress of the individual columns. This type of damage is observed for larger particles travelling at intermediate velocities and is thought to be due to a lower rate of energy input by the decelerating particle.

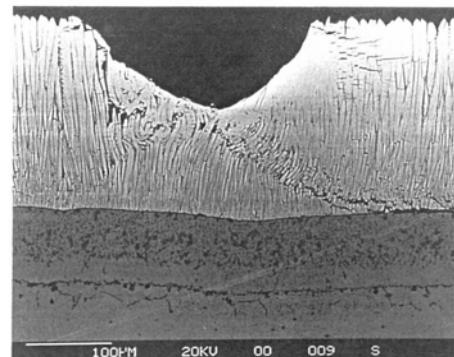
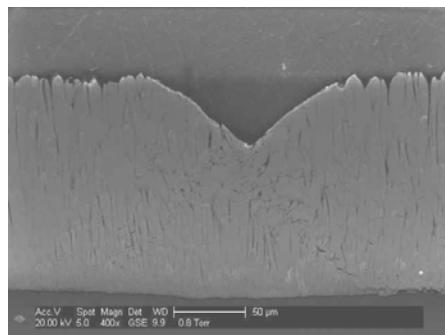
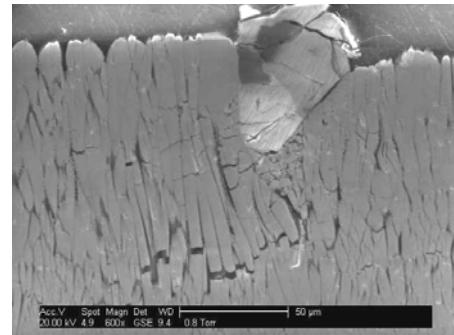
The mechanism of foreign object damage (FOD) is more complicated and involves gross plastic damage and shear bands within the TBC [10,21,39,47,51] often leading to cracks down to the metal oxide interface and thus large scale ceramic removal (see Figures 8a)-c) later in this paper).

FOD is caused by large particles travelling at low velocities or smaller particles at higher velocities and is characterised by significant deformation of the coating which can penetrate to the substrate and is accompanied by gross plasticity, deformation of the columns, shear bands and extensive cracking of the TBC ceramic [10,21,47,48,53,54] as illustrated in Figure 8. Clearly, the extent of gross plasticity observed varies with the component temperature when impacted, being greatest at 1200°C and less prevalent at room temperature.

Micrographs illustrating the effect of FOD in an EB PVD TBC, a) damage at 1200°C [21,55], b) damage at 900°C [1mm spherical alumina particle at an estimate 100m/s] [10] c) 800°C [39] d) damage at room temperature [0.5mm angular alumina particle at an estimated 100m/s] [39]

It is under conditions of FOD that the effect of temperature becomes most noticeable in that the mode of damage is directly affected by the temperature at which the impact occurs. After room temperature impact the columns are still visible as discreet features, whereas as the temperature increases, impact conditions result in the coating densifying as a whole. In other words the impact has caused adjacent columns to compact together so that they are no longer discreet columns.

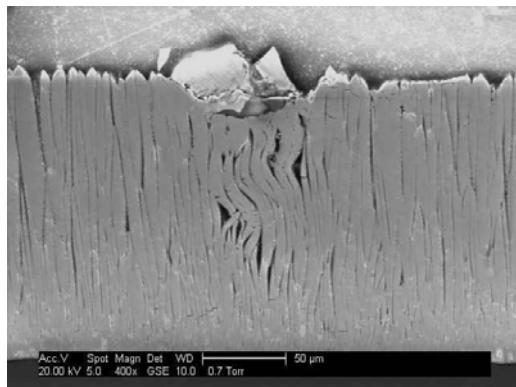
Further, recent studies have shown that, in fact, there are a number of distinct types of FOD. The SEM micrograph in Figure 9 illustrate an additional form of FOD damage – termed type 2 FOD – where significant column buckling is observed. This mode was observed in high velocity, gas gun FOD tests at Cranfield and demonstrates that EB PVD TBCs can deform plastically at elevated temperatures, in this case 800°C.

Figure 9 SEM micrograph illustrating type 2 FOD in EB PVD TBCs impacted at 800°C [39]

This mode of damage has only recently been observed in high temperature laboratory tests [39] and demonstrates the ability of EB PVD TBCs to deform plastically without densification occurring. As can be seen from Figure 9 the impacting particle has caused a number of columns in the coating to buckle with virtually no cracking occurring. From these experiments [39] this mode of deformation can be expected to occur at temperatures in excess of 800°C (being the temperature at which these tests were conducted) and possibly lower temperatures as well, provided the ceramic material exhibits sufficient plasticity.

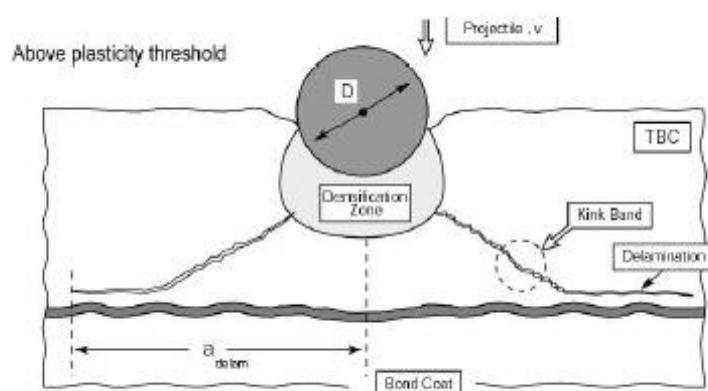
Work at Cambridge University, by Fleck and co-workers [55,56] has examined the loading deformation and fracture events during dynamic indentation of an EB-PVD TBC microstructure. Figure 10a schematically illustrates the problem. On impact an elastic stress wave propagates down the column, the wave can reflect from the coating/substrate interface or from internal defects within the columnar microstructure. The edge of each column is assumed to contain incipient cracks – the porous, dendrite like structures that result from the EB-PVD process, during TBC manufacture. This modelling work at Cambridge aims to address how these stress waves interact with the coating, the position of any peak stress that are generated and whether they are sufficient to cause fracture of the columns.

- a) Small particle impact - elastic impact between a spherical projectile and a plastic damage as a result of columnar microstructured ceramic

- b) Large particle impact elasto-coating FOD

Figure 10 Schematic diagrams of particle impact dynamics on an EB-PVD TBC [55,56]

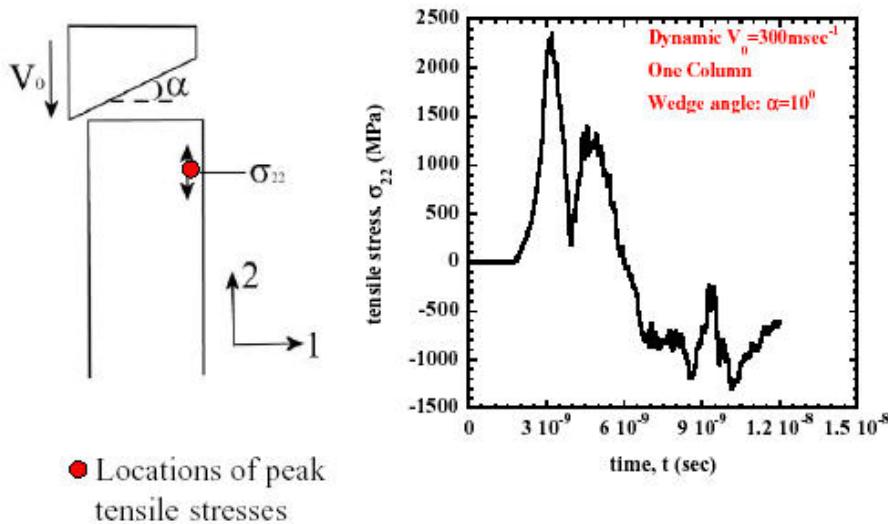
Figure 11 Wedge impact model of particle/TBC dynamics [56]

Considering first the elastic stress wave, the impact conditions can be simplified to a simple wedge impact problem, which can be analysed using finite element analysis. Figure 11 illustrates this model and the predicted tensile stress (σ_{22}) as a function of the elapsed time from impact. At an impact velocity of 300m/s and a wedge angle of $\alpha=10^\circ$ (α represents the contact angle between the impacting particle and a particular column) a peak stress of 2.5 GPa is calculated. The elapsed time to this peak stress condition is just greater than 3ns, which corresponds to the onset of cracking 10 μ m from the top of the column [55,56].

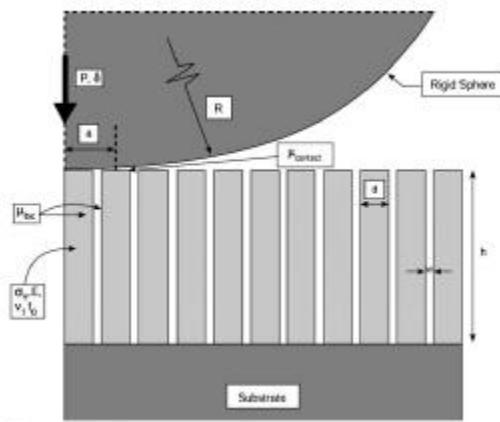
The finite element model, proposed by Evans and coworkers [53] is axisymmetric (Figure 12), with the columnar microstructure approximated by a series of concentric cylinders, with gaps between each cylinder. Thus, the role of contact between columns can be explored by varying the properties of this intra-column region [53,55]. As part of this modelling work, Evans and co-workers have identified a number of important dimensionless groups and have examined the relationship between them. The impact energy can be normalized [54,55,59] as:

Figure 12 Schematic model for indentation of an EB-PVD microstructure [53]

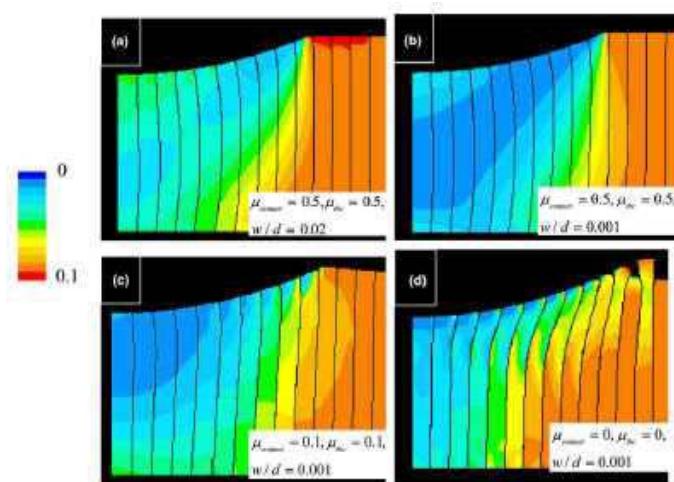
Figure 13 Trends in column deformation and densification as a function of contact friction and intra-column friction [53]

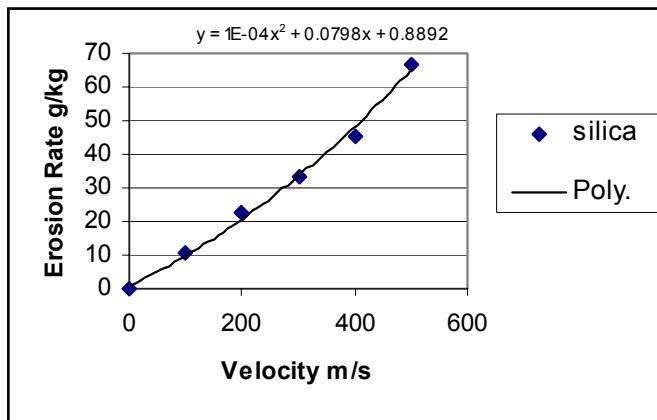
As one further example, the literature reports a linear increase in erosion rate with velocity in the 100 to 300 m/s velocity range. Experimental studies at Cranfield also support this, showing that $E = cV$, where c is 0.102 for silica at room temperature and c is 0.131 for angular alumina particle, also at room temperature. [47,48]. The predicted erosion rates are also almost linear in this region with a value for c of 0.13. The degree of fit is apparent from Figure 14.

Figure 14: Predicted erosion rate of EB-PVD TBC eroded with Silica at room temperature.

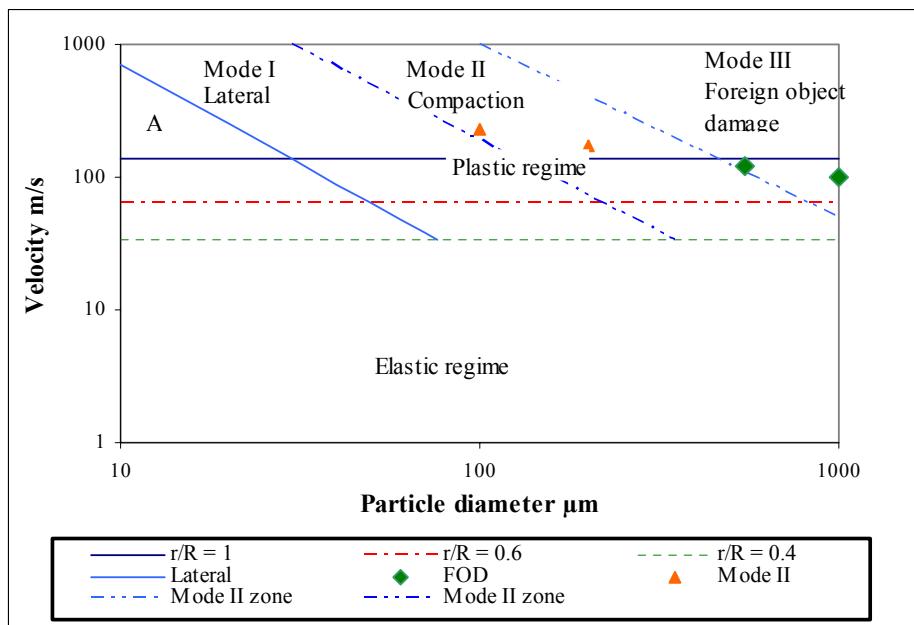
Figure 15 [57] illustrates an erosion map deduced for impact damage to an EB-PVD TBC, eroded with silica particles. In deriving this map from experimental data, there are three important factors to note. Firstly, the transition velocity from elastic to plastic damage is assumed independent of particle size, but is dependent on the particle shape. Thus the term (r/R) in the map relates the effective particle radius (r) to the mass average particle radius (R) and included on the map are three positions for this elastic/plastic transition, depending on the (r/R) ratio, plotted for (r/R) ratios of 0.4, 0.6 and 1.0.

Finally, the area labeled ‘A’ is of interest. It is a region of the map where near surface plastic damage should occur, but without lateral cracks initiating. One can hypothesis that in this region, material could be removed by some “accumulation of plastic damage” although this has not been incorporated in the current version of the Monté Carlo model. For the model to be valid in this region it would be necessary to accumulate strain, when columns are impacted, until some critical value whereupon fracture occurs. A Manson-Coffin relationship, as proposed by Stephenson and Nicholls [66] in modelling oxide erosion, seems appropriate.

In summary erosion mapping allows one to determine experimentally the boundary conditions for a given erosion damage mechanism, and thus the valid bounds for a particular erosion model. It should be noted that the erosion map, reproduced in Figure 15, was generated based on room temperature data/perceived erosion mechanisms operating at low to intermediate temperatures. The map can be applied at high temperatures provided the erosion mechanisms do not change significantly, nor do the mechanical properties of the ceramic top-coat, bondcoat or erodent particles. Under high temperature conditions, the map agrees well with impact damage caused by hard particles such as alumina, but is not valid for impacts by partially molten/pasty silica particles. This is associated with a change in material removal mechanism when an EB-PVD TBC is impacted by partially molten/pasty silica particles [47] for which a maximum in erosion rate is observed for 30° impacts.

Figure 15 Erosion map for an EB-PVD thermal barrier coating eroded with silica Particles [57]
